ALCATEK CONTROL SYSTEMS LTD

Technical Bulletin 971

ISSUE 1 – DATED 11.June.12

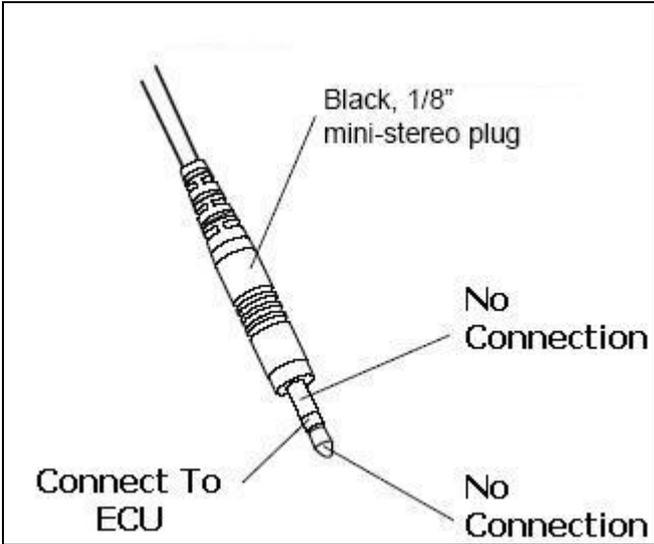
Diagram of modified cable

The short 'Patch Cable' (Innovate P/N 3789) supplied with the LC-1, requires modification. You should cut ONE of the 2.5mm plugs off the cable. Then strip the remaining cable back, to reveal the two internal conductors. You only need to connect to one of these; the one that connects to the 'Ring' on the 2.5mm plug. The other wire, and the screen should be insulated, as they are not required. See the diagram on Page 2 for details. On the cable we tested, this was the Brown wire; but you should confirm the connection using a continuity tester.

The wire from the 'Ring' terminal, should connect to pin 'C4' on the ECU.
